Eliseparts Gear Linkage Kit

Fitting instructions

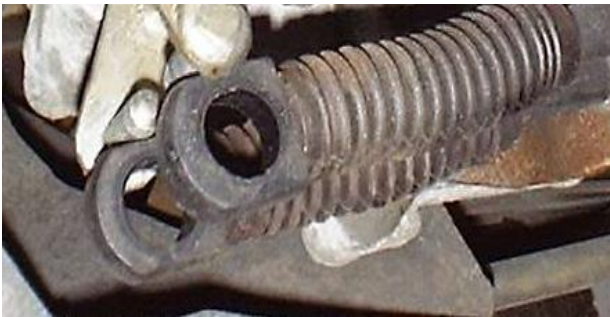
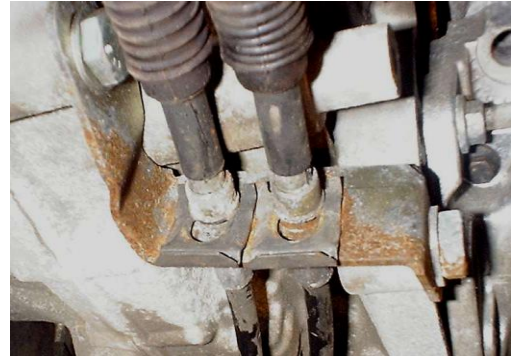
1. Raise the rear of the car so that you can comfortably work underneath it, making sure that it is secure.
2. Remove rear under-tray. This has 5 bolts at the rear edge, 6 at the edge of the front sides (3 each side) and 4 in the middle.
3. Remove the two gear cable clips (shown right), being careful not to lose them as they spring out. Remember

the cables cross over and put back the same way as removed

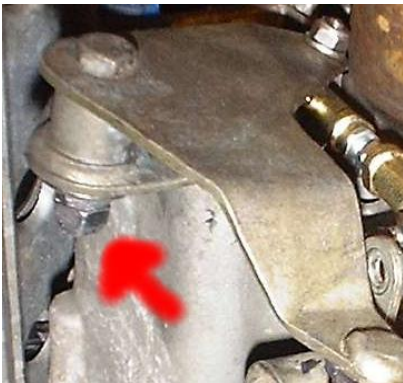
4. Push out the old rubber bushes from the ends of the gear cables, then, move the cable out of the way.
5. Remove Nyloc and Lock nut from bell crank, (using 2x10mm spanners) and push the link clear from the bracket.

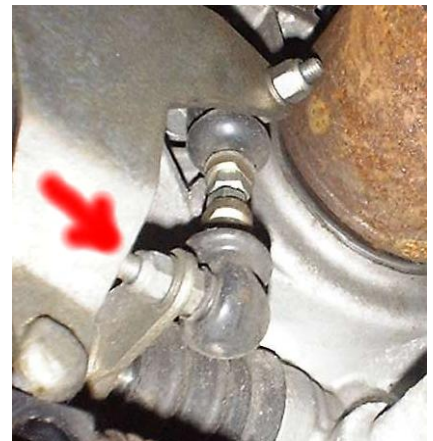
6. Remove the bell-crank nuts (shown left), this is a Nyloc and half nut. When removed, the bell-crank should be slid off with the old joints attached.

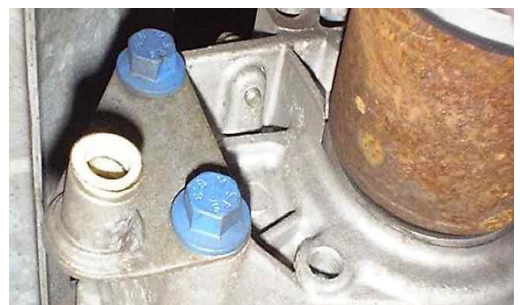
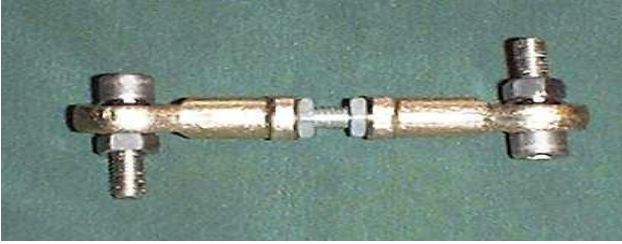
7. Push out the old Nylon bushes from the bell crank support bracket, (there are two of them, one from each side).
Clean up the bracket, and insert the new Nylatron bushes taking care not to damage them, and then smear with grease (supplied).

8. Remove the old rod ends from the bell-crank and then dis-assemble them from each other. Make up the new rod ends to mimic the old ones, setting the distance from the centres to the same as the old ones (this should be 70mm). Then bolt one end back to the bell-crank as shown.

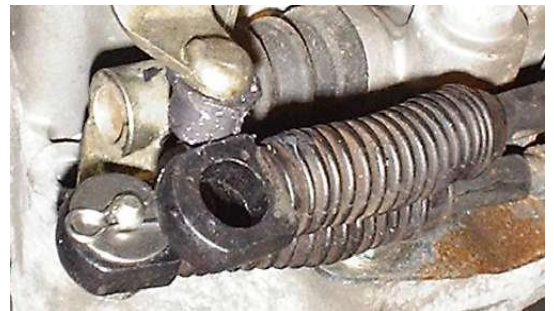
11. Push the gear cable Nylatron bushes over the cleaned up pivot points. Once the cable ends have been greased, these can then be pushed over the Nylatron bush, followed by the M8 washer and secured by the 'R' clip (as shown).NB* Grease all surfaces liberally.

12. Replace the cable clips. The whole assembly should look something like this.

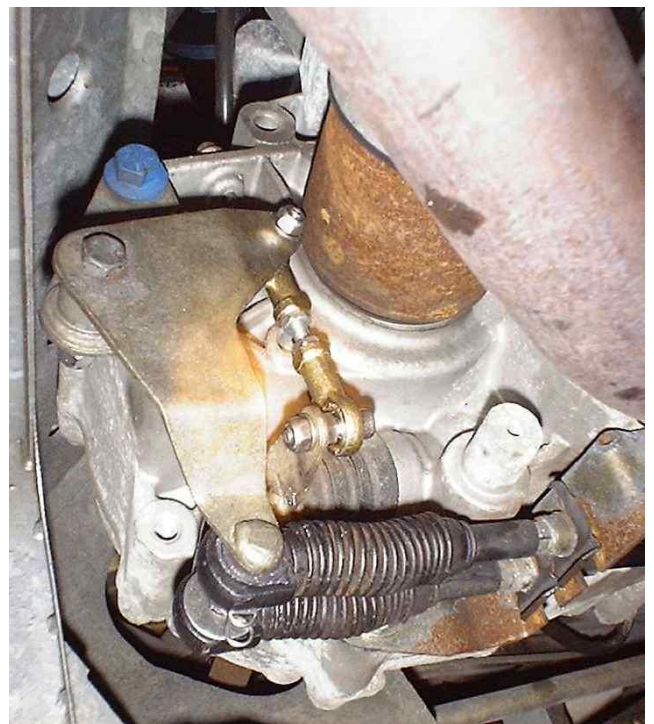
All that needs to be done now is to check that you can reach all the gears; this is best done with an assistant. Whilst watching the linkage get the assistant to select 2nd Gear, and then 5th gear. If all is well, tighten up the lock-nuts between the rod-ends, making sure that they can still articulate.

If you can't reach 2nd, then you need to shorten the distance between the rod-ends, if you can't reach 5th, you will need to lengthen the link. To adjust the link, un-bolt the lower rod-end from the selector bracket, then turn clockwise (to shorten) or anti-clockwise (to lengthen), then re-fit.
